**Docket No. 217 – Development and Management Plan Inspection**

**Date:** September 7, 2006

**Location:** 345kV Underground Route

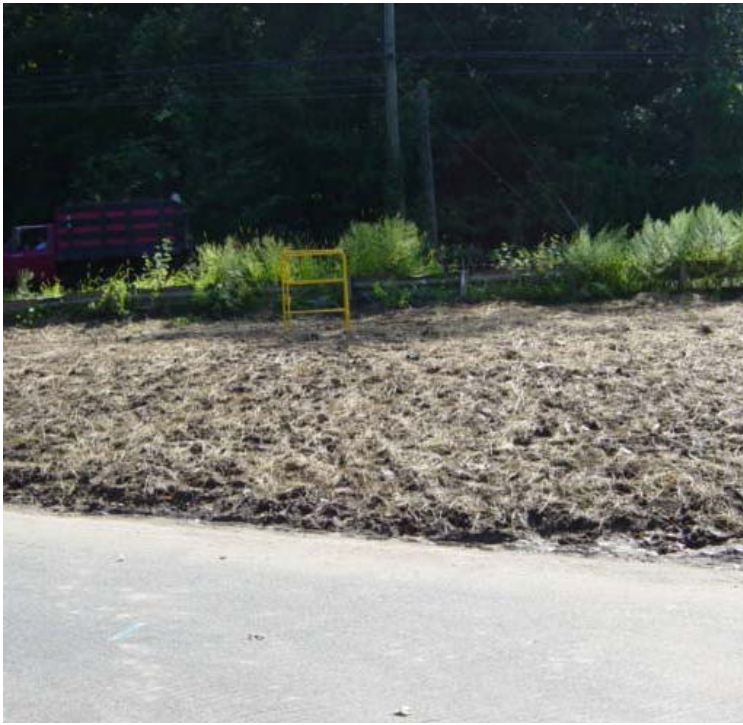
345kV: Both photos show the restoration efforts near Old Danbury Rd. Photo on the left shows the vault area was mulched although work continues here. Photo on the right shows additional erosion control matting installed along the slope here. 9/7/06

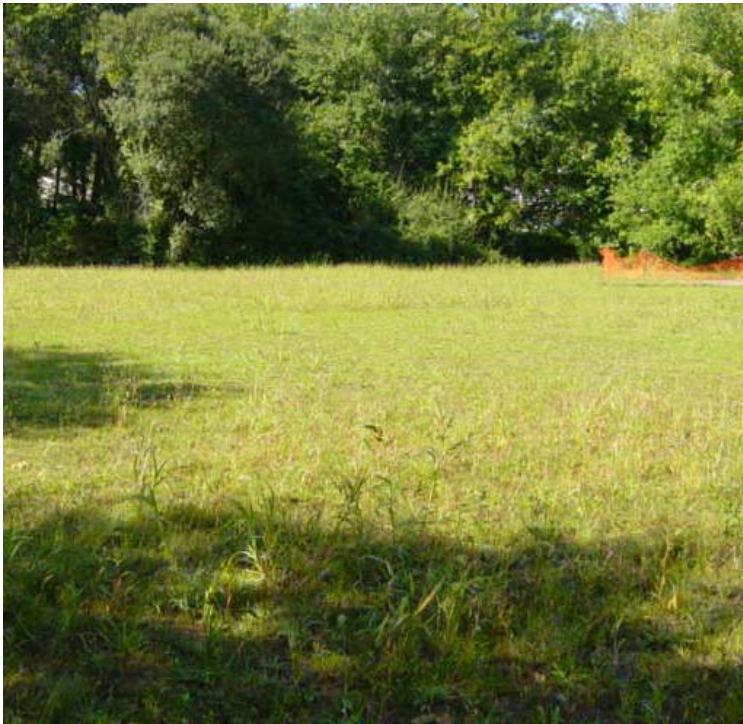
Photo on the left shows the overall School Rd. site. Grass and vegetative cover continue to establish. Photo on the right shows revegetation in the previously disturbed wetland area. 9/7/06

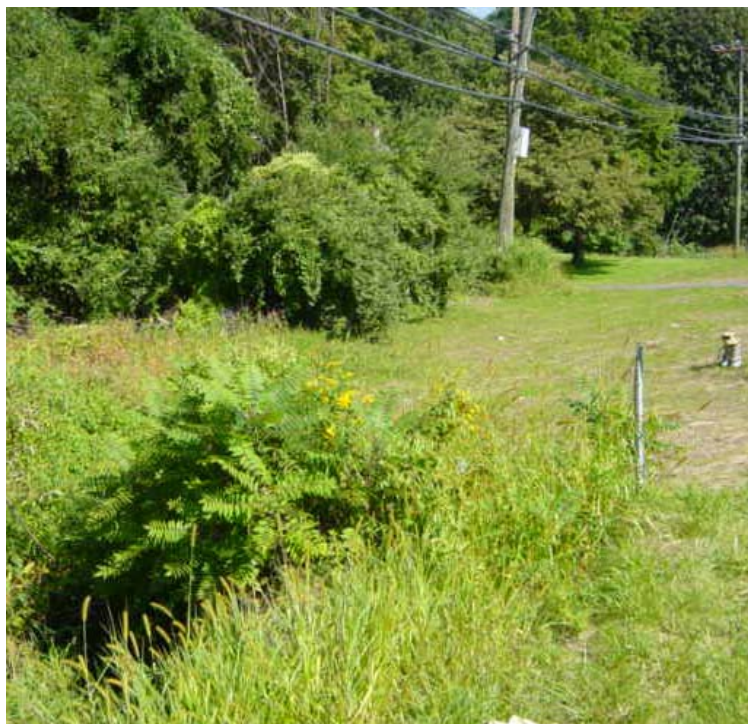
Photo on the left shows the restored area leading towards Allens Meadow Park with established grass cover. Vegetation along the streambank here is also in good shape. Photo on the right shows the storage area near the Rt 107/7 intersection which has demobilized. The disturbed area has been

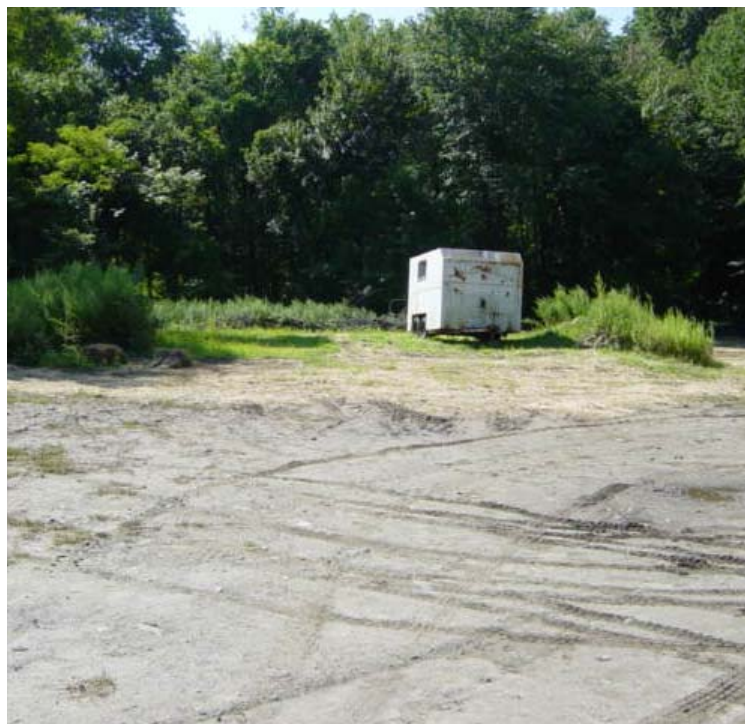
restored. 9/7/06

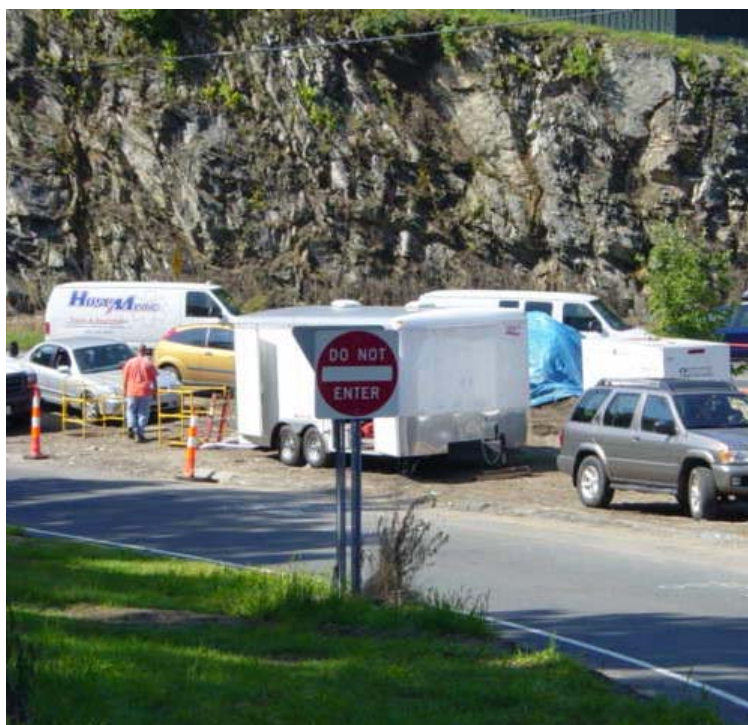
- Active work continues at the Rt 7/107 intersection. Catch basins in the area do not have controls and there is adjacent disturbed soil. 8/24-9/7/06 - Stockpiles have been covered 9/7/06	-See erosion control section. 8/16-9/7/06	- Needs attention. (Stockpiles have been covered)
Erosion and Sediment (E&S) Controls	- Grass growth appears to have slowed at the high school J&B due to the weather 7/26-9/7/06	- Continue to monitor as grass is patchy but seems stable for the most part. 7/26-9/7/06	- N/A

Photo on the left shows continuing work at the vault at the Rt 107/7 intersection. Adjacent catch basins still need controls. Stockpiles are covered. Photo on the right shows a view of the silt fence installed at the Gilbert & Bennett lot. Seed and mulch are still needed here along the slope. 9/7/06
